Operation **TEAPOT**

Project 31.2

**DAMAGE TO COMMERCIAL AND INDUSTRIAL BUILDINGS
EXPOSED TO NUCLEAR EFFECTS**

Report to the Test Director

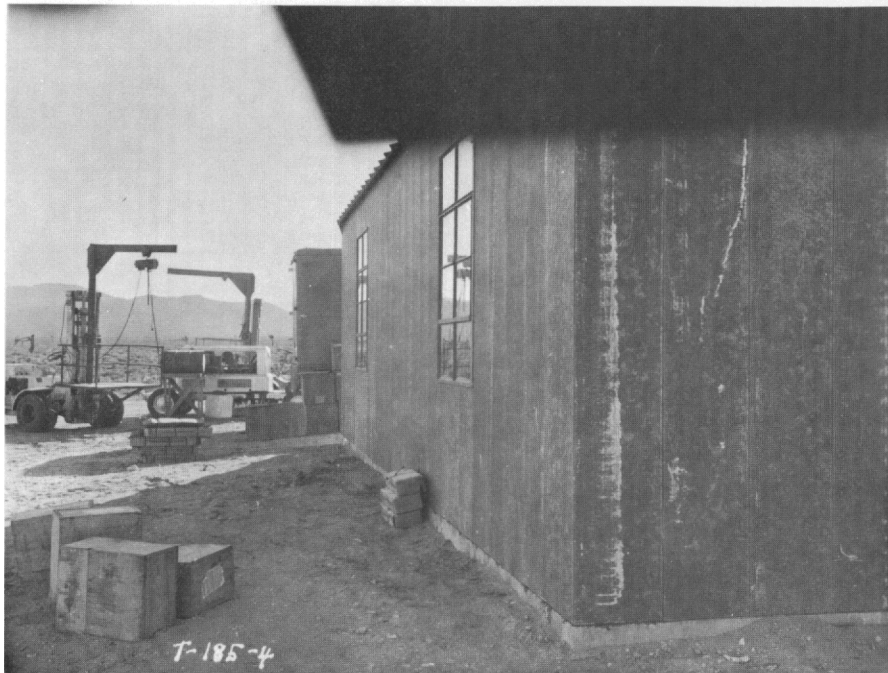
Fig. 1.22—Armco Building 31.2-d1 repaired after unexpected test.

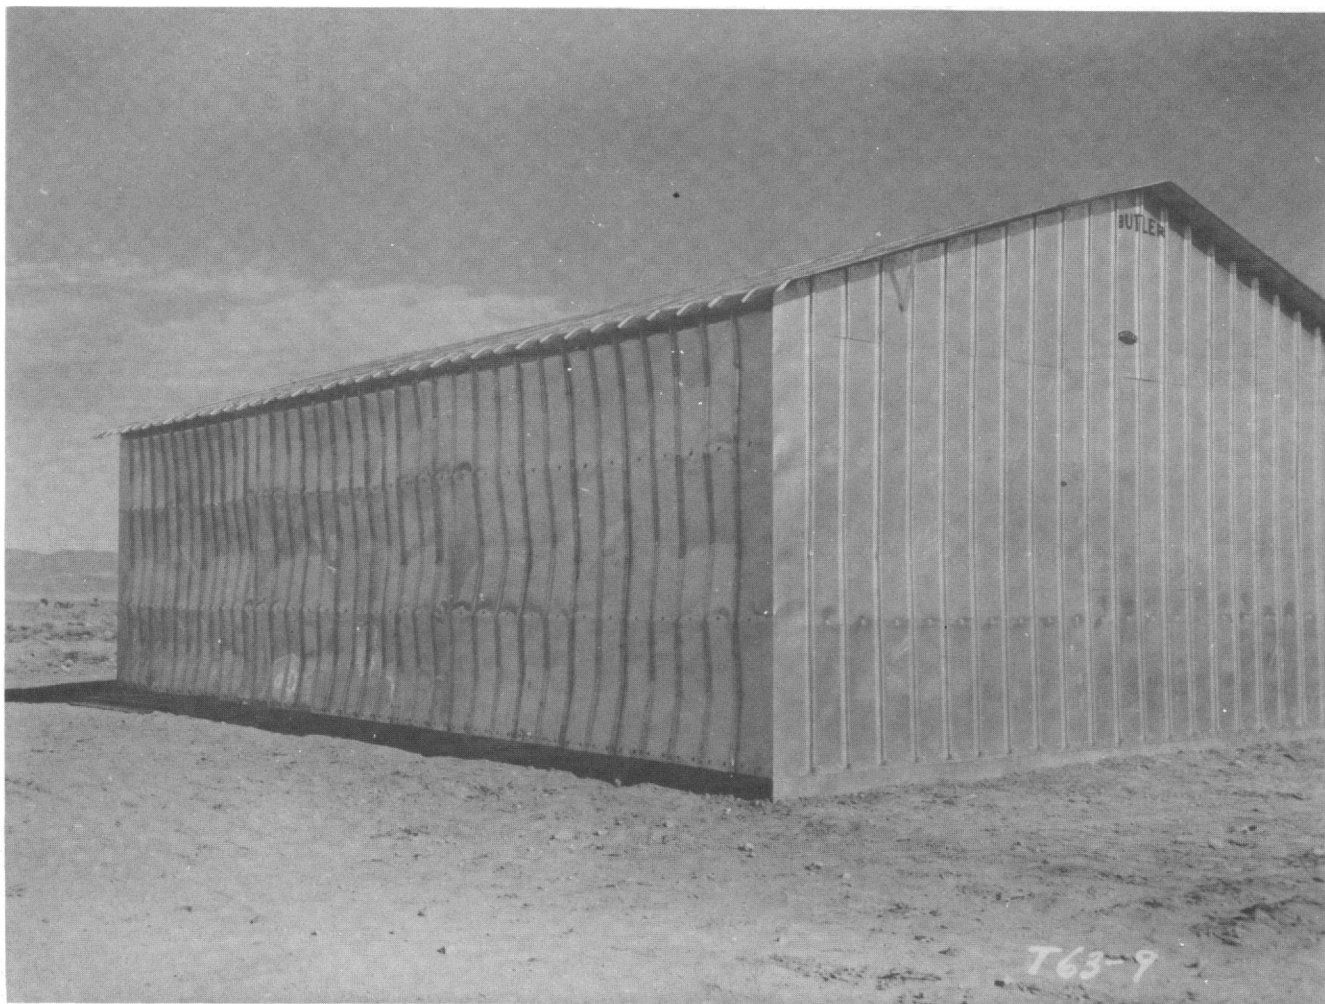
Figure 2.1 gives a general indication of the damage from the unexpected test to the north wall of Reynolds-Butler Building 31.2-a1, which was left with permanent inward deflections up to 5 in. The offset measurements, as recorded at the site, are tabulated in Fig. 2.2 for both the unexpected and planned tests. The two wall girts were bent in along with the paneling, and the bolt heads of the panel fasteners were generally pulled through the sheeting. Washers had been omitted along these two lines of bolts, and hence no definite conclusion can be made as to the probable extent of pull through if they had been included. The roof sheeting was left with downward permanent sets, especially in the span immediately adjacent to the eaves, where the permanent deflections, as shown in Fig. 2.3 and recorded in Fig. 2.2, were measured up to 3 in. The roof purlins were not deformed appreciably. The interior view of the wall (Fig. 2.4) shows how twisting of the girts occurred with measured values up to 43°. It is also of interest to note the imprint of the wind-bracing ties on the wall paneling, indicative of the initial deflections that were experienced. A dynamic analysis of wall behavior in both the unexpected and planned tests is provided in Appendix A.

As shown in Fig. 2.1, the panels on the west end of the building suffered very little permanent deformation. The unexpected test involved a moderate northeast exposure, and at the east end, as indicated in Fig. 2.5, the panels were bent inward to a degree comparable with those on the north side. This picture was made during the process of repair, with damaged north and south wall panels removed but with the bent and twisted wall girts still in position.

Fig. 2.1—General view of north and west end walls, showing damage from unexpected test to Reynolds-Butler Building 31.2-a1.

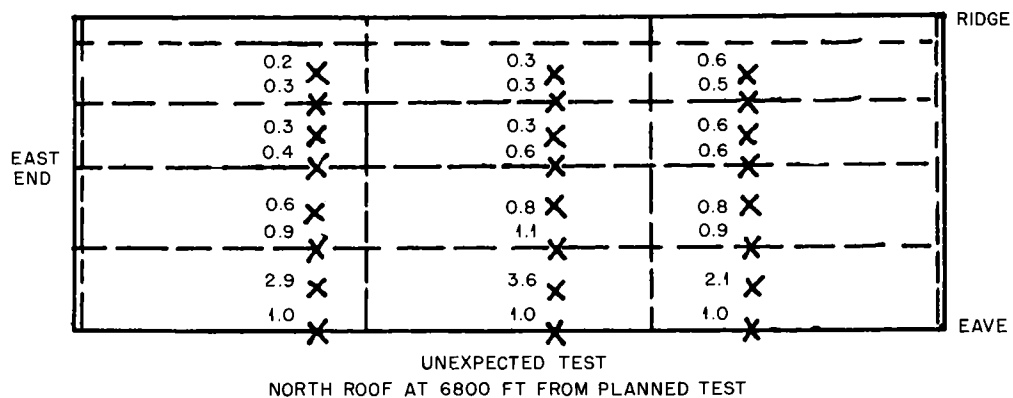
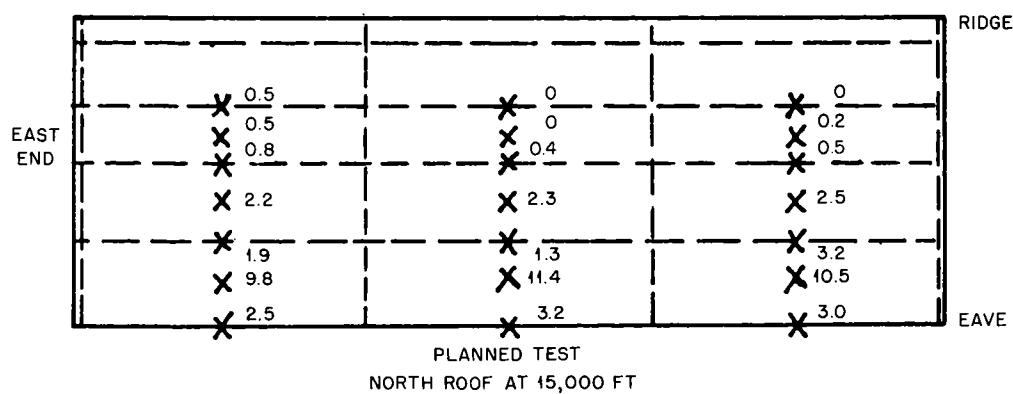
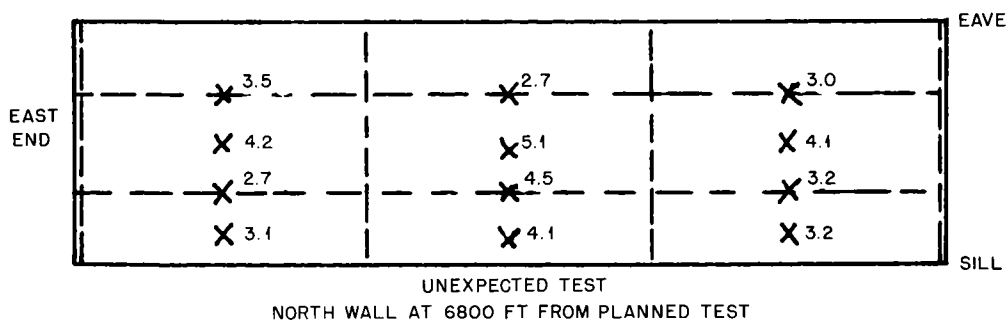
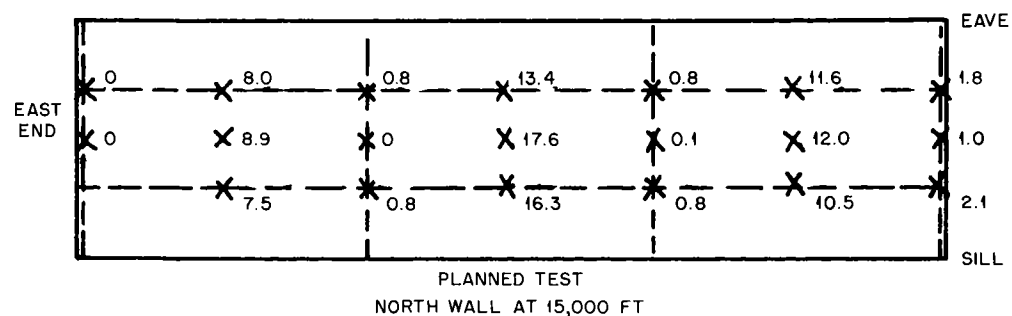
Fig. 2.2—Offset measurements of permanent wall and roof deflections in inches in Reynolds-Butler buildings in which sheeting remained in place.

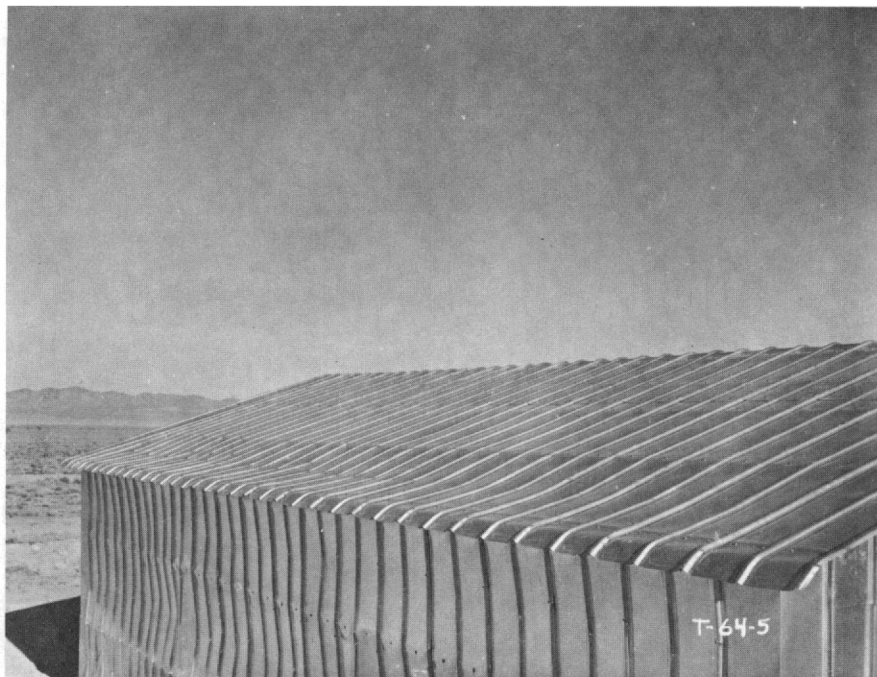
Fig. 2.3 — Damage to roof of Reynolds-Butler Building 31.2-a1 from unexpected test.

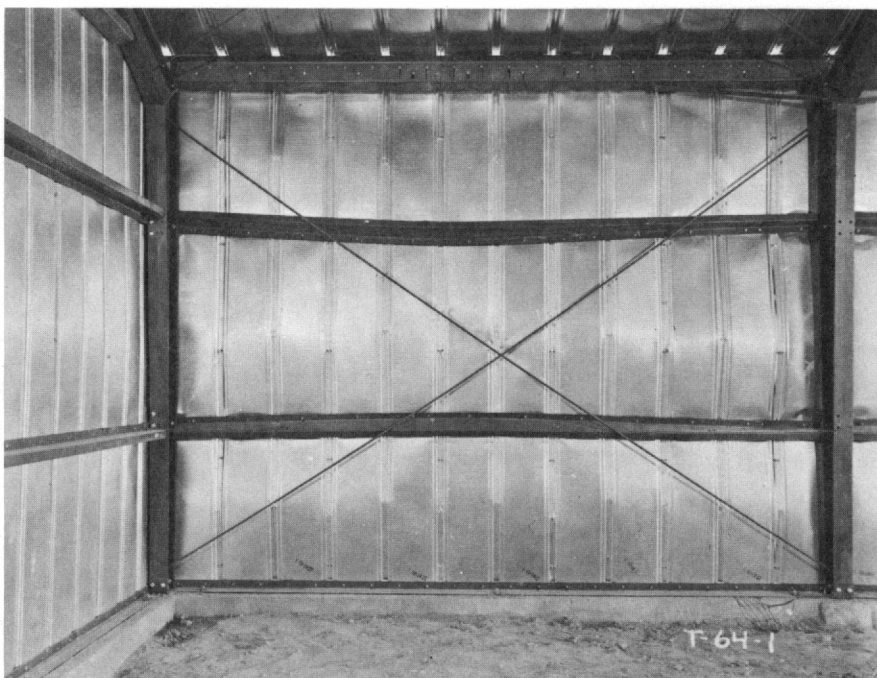
Fig. 2.4 — Interior view of damage to north wall in Reynolds-Butler Building 31.2-a1 from unexpected test.

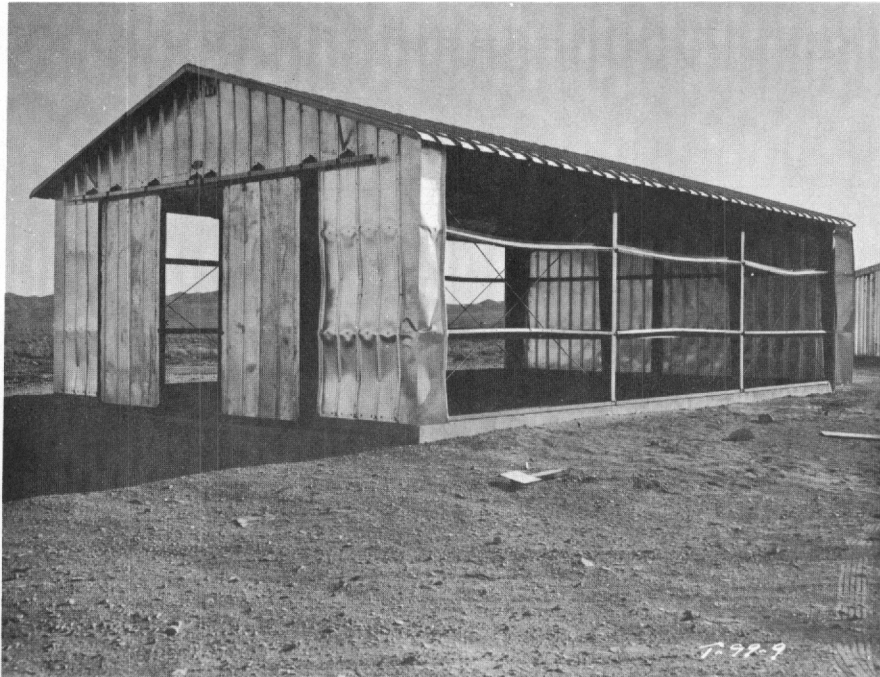
Fig. 2.5—North and south sides of Reynolds-Butler Building 31.2-a1 during repair of damage from unexpected test.

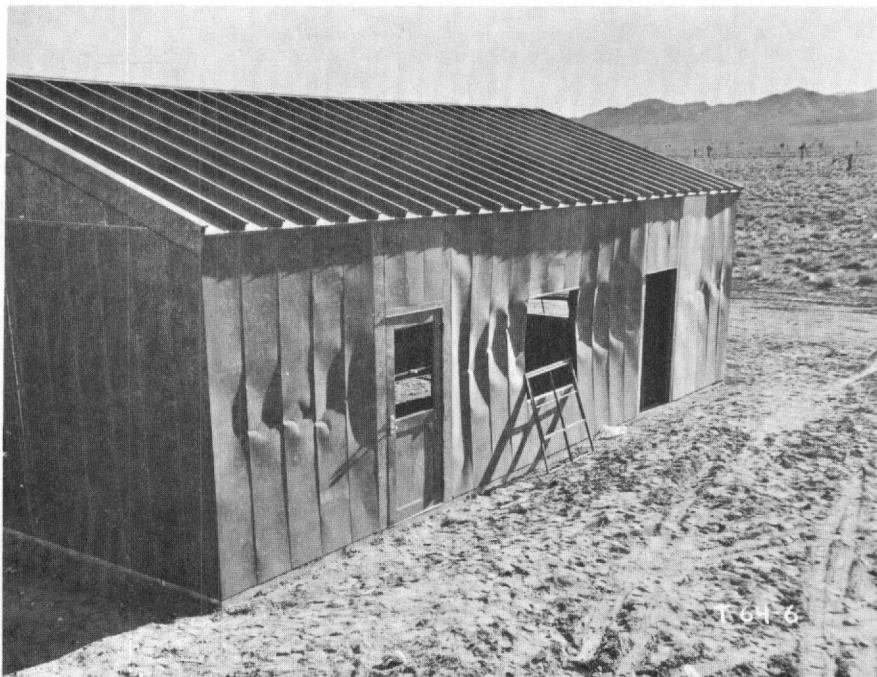
Fig. 2.6—Damage to north walls of Armco Building 31.2-d1 from unexpected test.

Permanent deflections along the north side of Armco Building 31.2-d1 are shown in Fig. 2.6 and are recorded in Fig. 2.7. The first five wall panels on the east and nearest the blast origin were damaged to a lesser extent. Maximum permanent deflections of the north wall, amounting to 4.8 in., were measured adjacent to the north window. Figure 2.8 shows the local buckling on the inside of the north wall near the location of maximum deflection. This building,

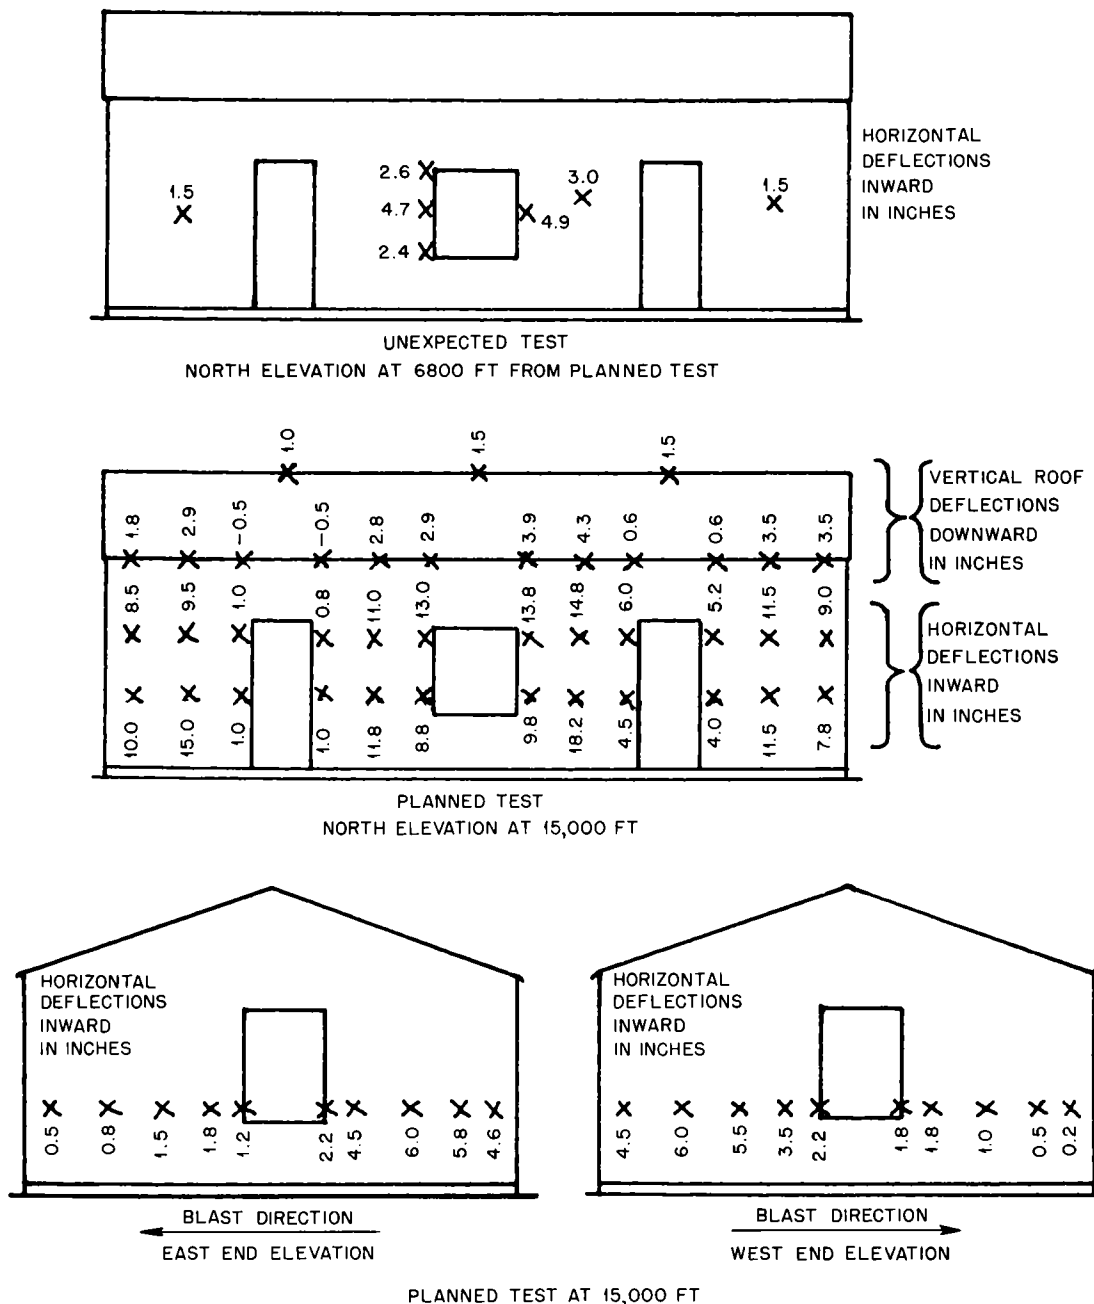
Fig. 2.7—Offset measurements of permanent wall and roof deflections in inches in Armco buildings that remained intact.

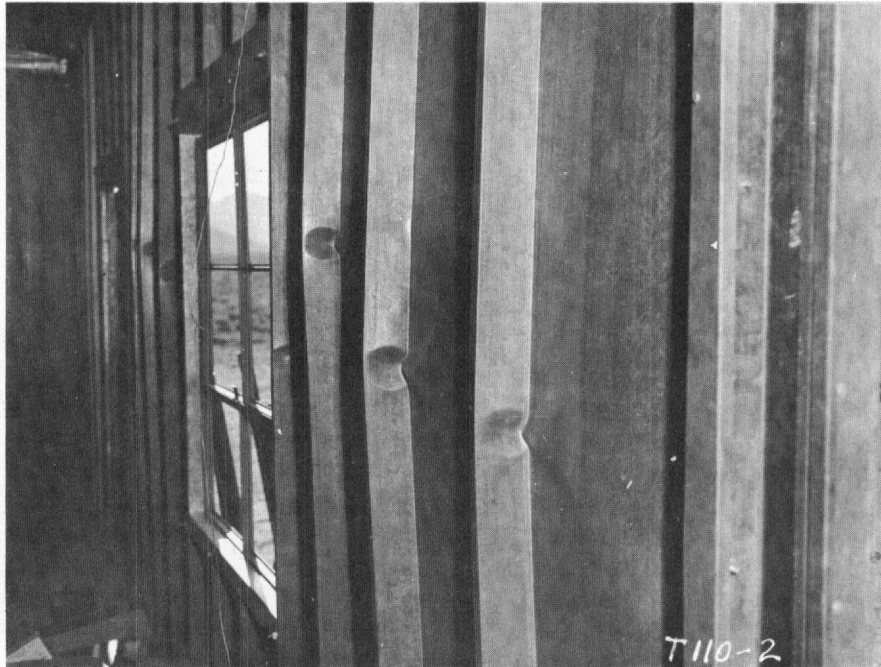
Fig. 2.8—Interior view of damage to north wall of Armco Building 31.2-d1 from unexpected test.

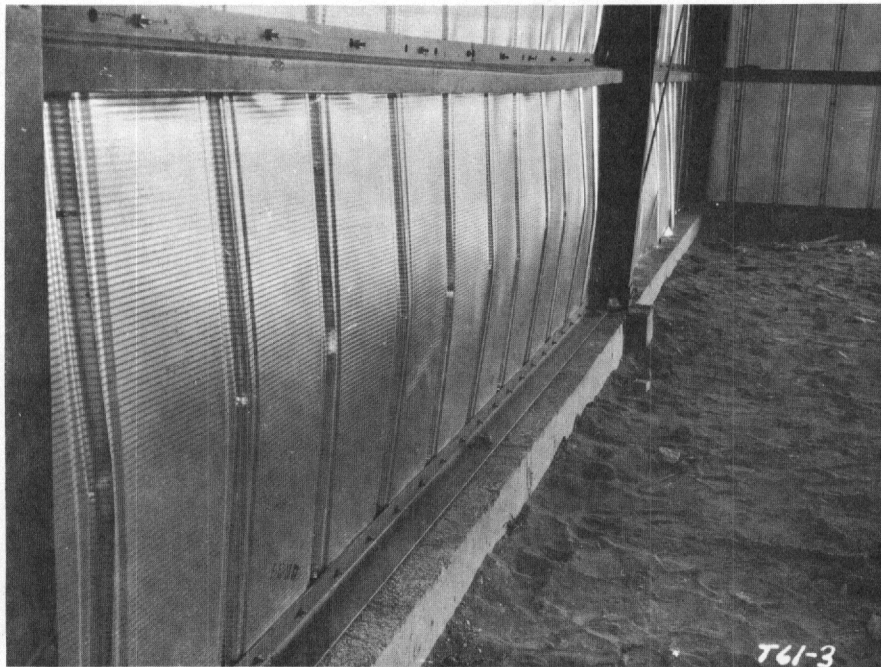
Fig. 2.9—Interior view of wall damage in Reynolds-Butler Building 31.2-a2 from unexpected test.

The roof sheeting on Reynolds-Butler Building 31.2-a2 had not been placed, and the blast caused movement of both walls away from the blast origin, damaging both paneling and girts to a very minor extent. Deflections of the wall paneling on the north side amounted to as much as 2 in. in the lowest space, as shown in the interior view (Fig. 2.9). Washers had been installed properly with all bolts, and no bolts pulled through the sheeting on the north face, although two bolts with washers did pull through the south face sheeting due to the negative aspect of the behavior with an open roof.

Reynolds-Butler Building 31.2-a2, at 15,000 ft, was repaired by replacing damaged wall girts on both the south and north sides and by replacing all wall panels on the north side only.

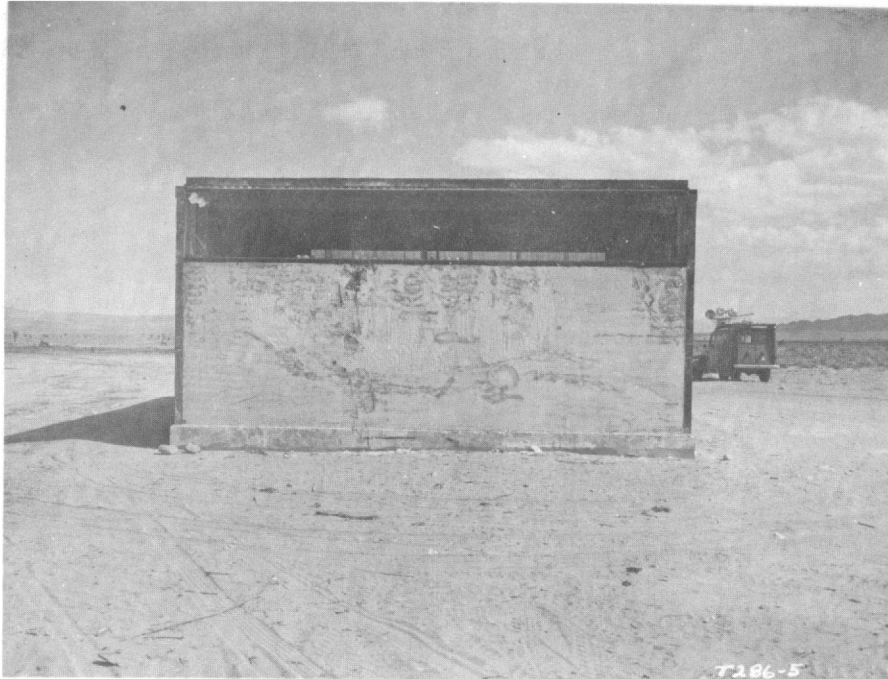
Fig. 2.10 — North wall of Union Carbide building after planned test.

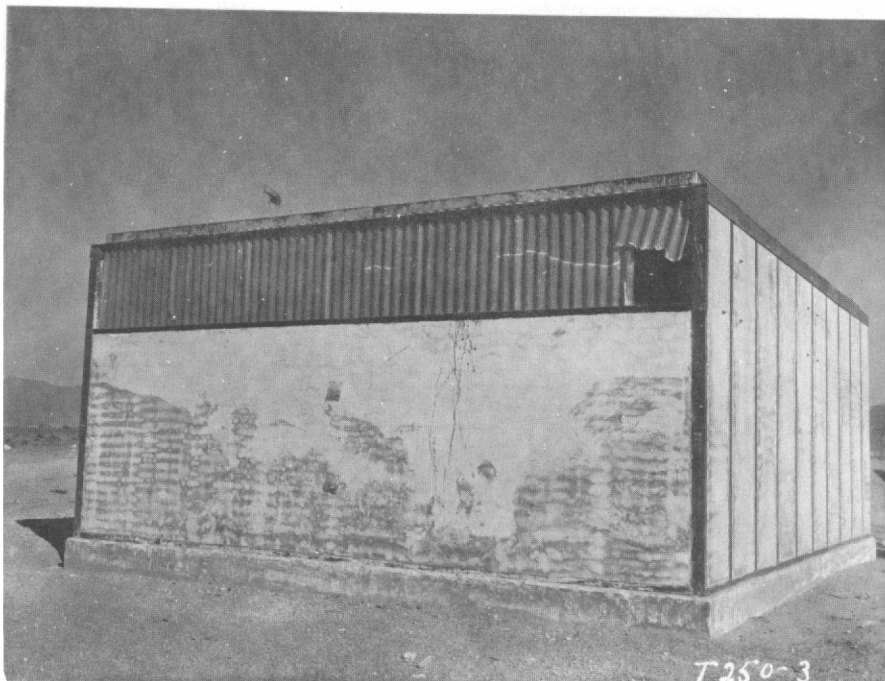
Fig. 2.11 — South wall of Union Carbide building after planned test.

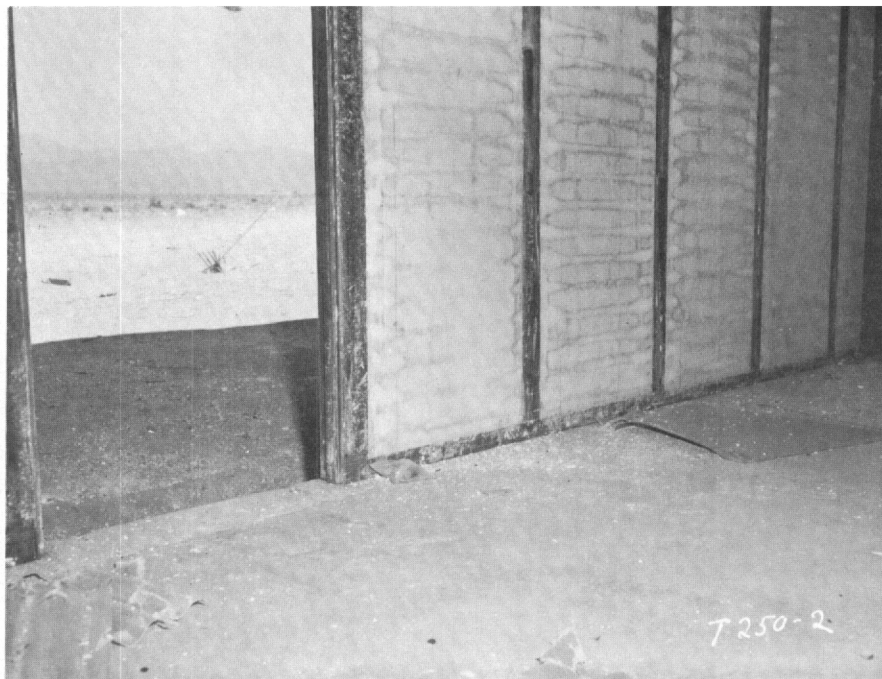
Fig. 2.12—Interior view looking out doorway of Union Carbide building after planned test.

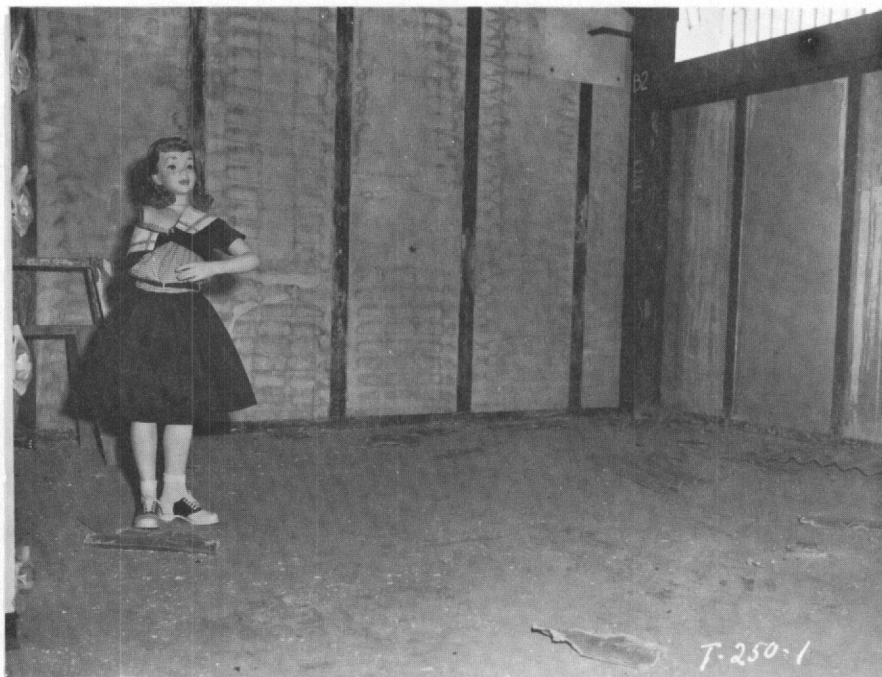
Fig. 2.13—Interior view of southeast corner of Union Carbide building after planned test.

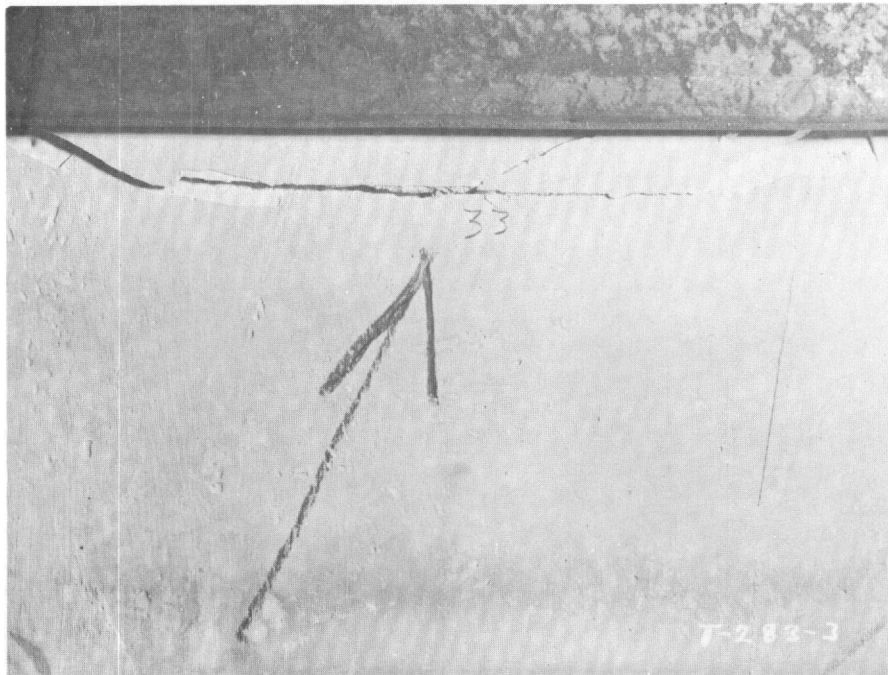
Fig. 2.16 — Shear crack at top of west wall north of Union Carbide building.

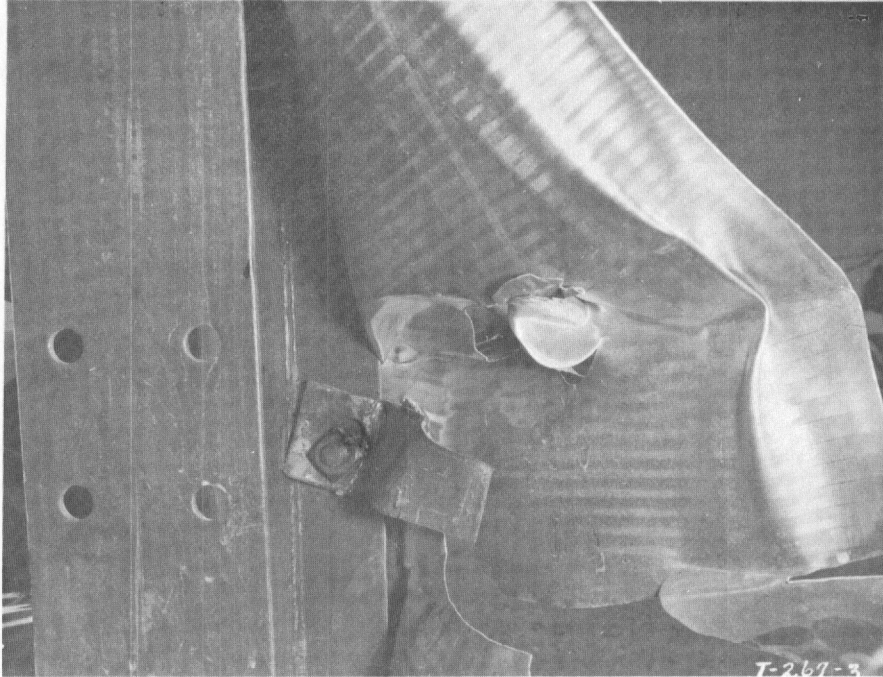
Fig. 2.21 — Interior detail of torn girt connector north of Reynolds-Butler Building 31.2-a1 after planned test.

Figure 2.21 shows the detail of a torn girt connector which is typical of the end failures of this member. Approximately one-half of the total girt area is cut away at this point to provide sufficient coping of the Z bar in order to eliminate interference between the exterior panel and the front face of the columns. The girt is then attached by a single $\frac{1}{2}$ -in.-diameter bolt passing through a slotted hole. Initially, the slotted hole permits a longitudinal movement of the girt which is resisted only by the friction between the bolt and the girt material. Then at the sharp internal cut, the girt starts to tear at the end. As it does so, the torn piece of girt that remains attached to the column is twisted almost 90° , as shown in Fig. 2.21. There is some information available on the strength of eccentrically loaded tension members of steel which fail by tearing that starts at one side, due to a notch or stress concentration, and information¹ is also available on the strength of bolts in shear. The fact that the bolts did not fail

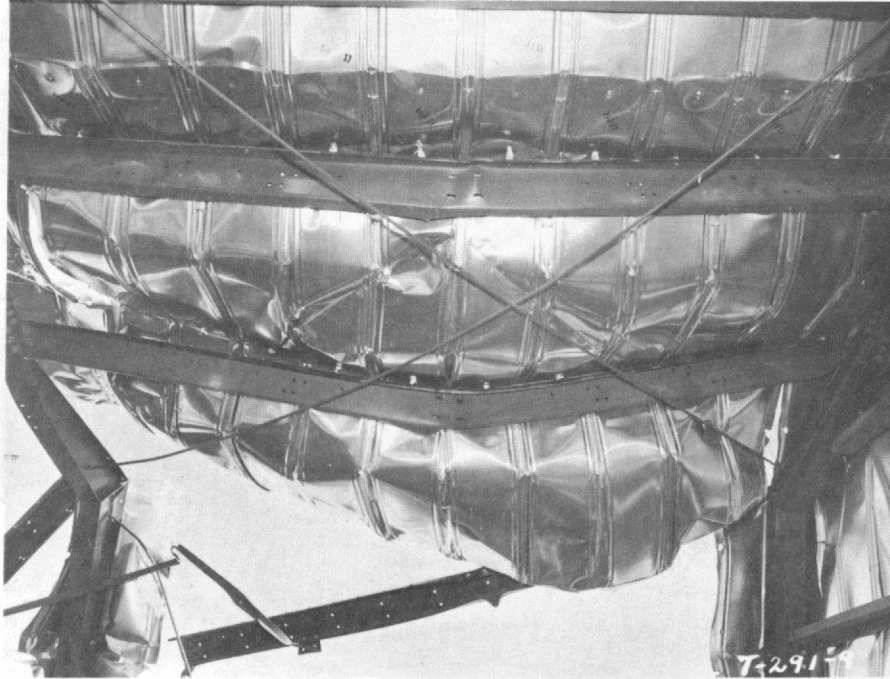
Fig. 2.23—Roof purlins at northeast corner of Reynolds-Butler Building 31.2-a1 after planned test.

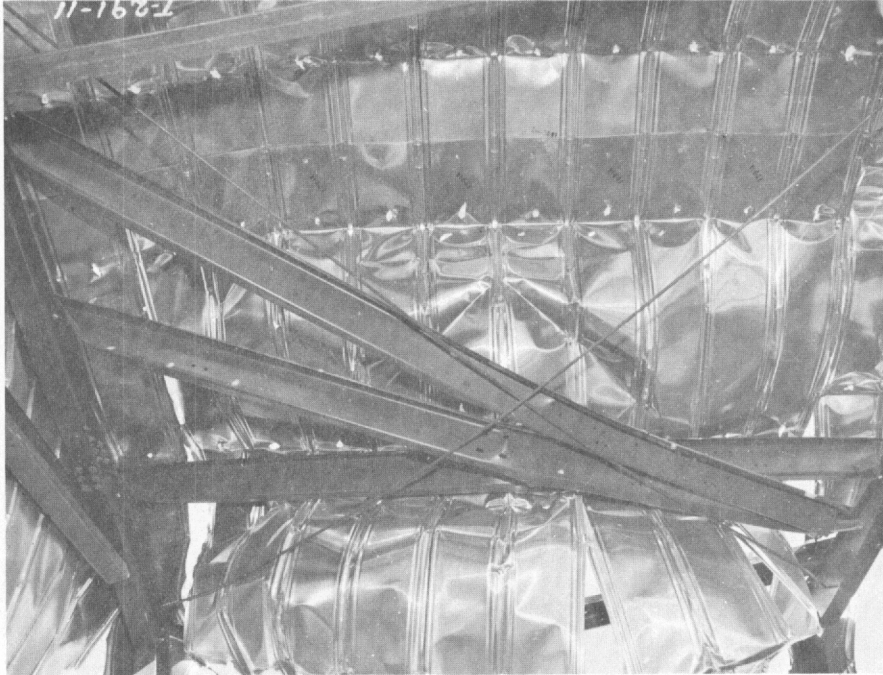
Fig. 2.25 — Underside of roof at northwest corner of Reynolds-Butler Building 31.2-a1 after planned test.

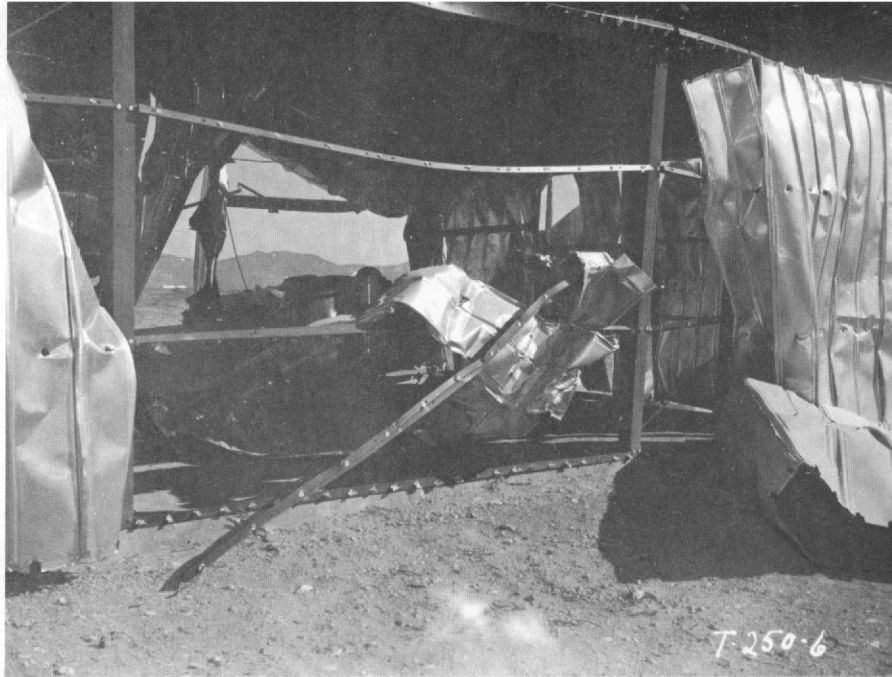
Fig. 2.27—North girts and siding blown through south wall of Reynolds-Butler Building 31.2-a1 after planned test.

shown in Fig. 2.27. They survived the experience of having the central wall girts and sheeting from the north wall blown against them after striking machinery within the building. Except along the ridge, the roof sheeting was largely detached from the purlins. The purlins on the south face of the roof were the least damaged of any sheet-supporting members, as shown in Fig. 2.28, a view looking upward at the east space of the south roof face.

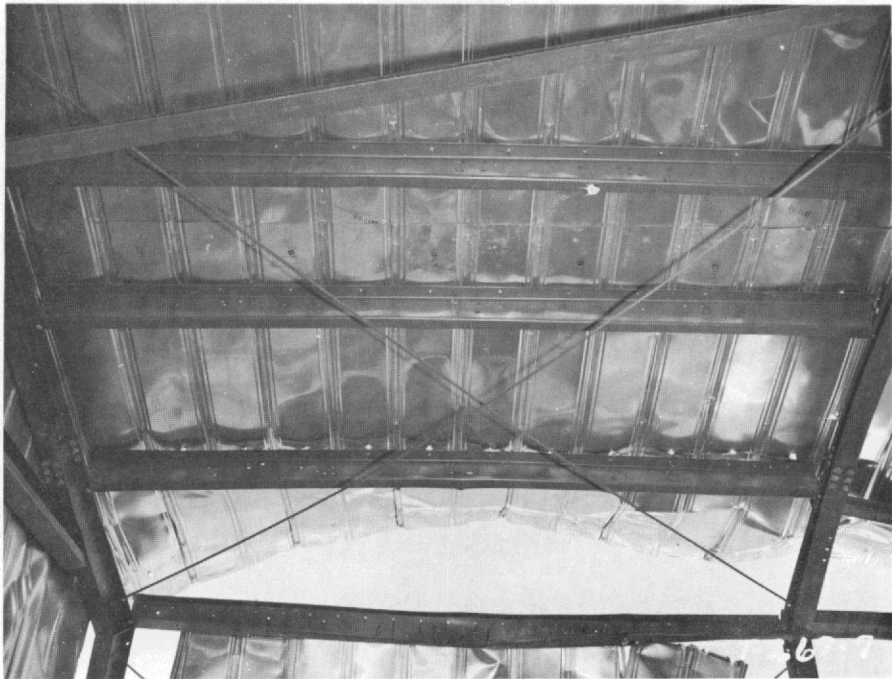
Fig. 2.28—Underside of southeast roof section of Reynolds-Butler Building 31.2-a1 after planned test.

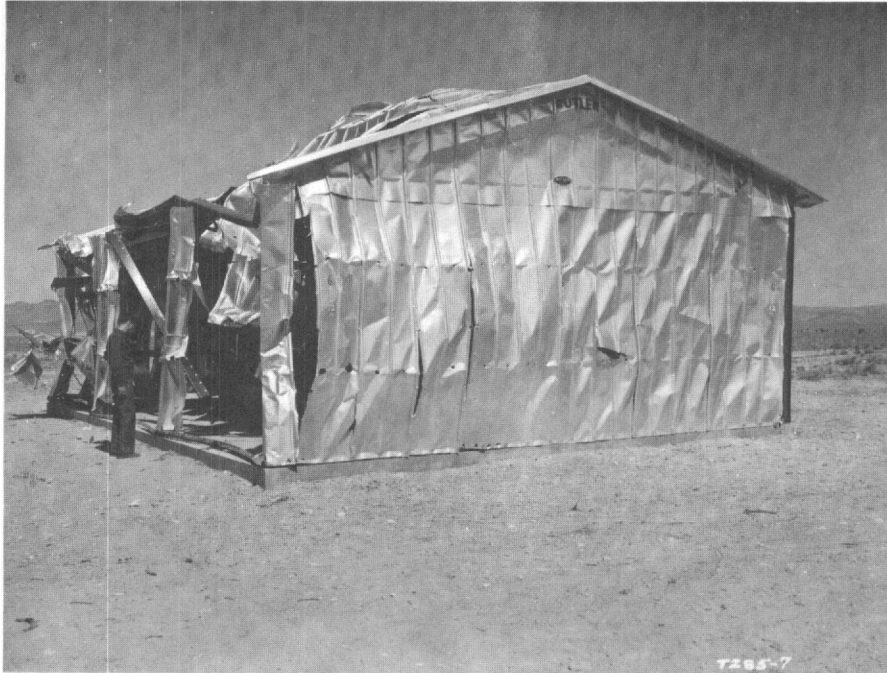
Fig. 2.29—West end of Reynolds-Butler Building 31.2-a1 after planned test.

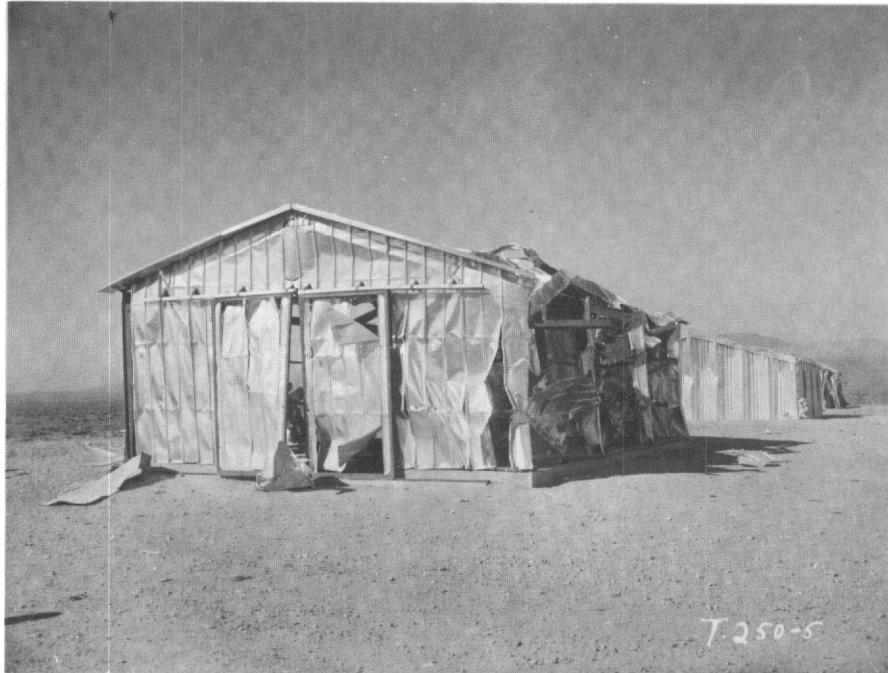
Fig. 2.30—East end of Reynolds-Butler Building 31.2-a1 after planned test.

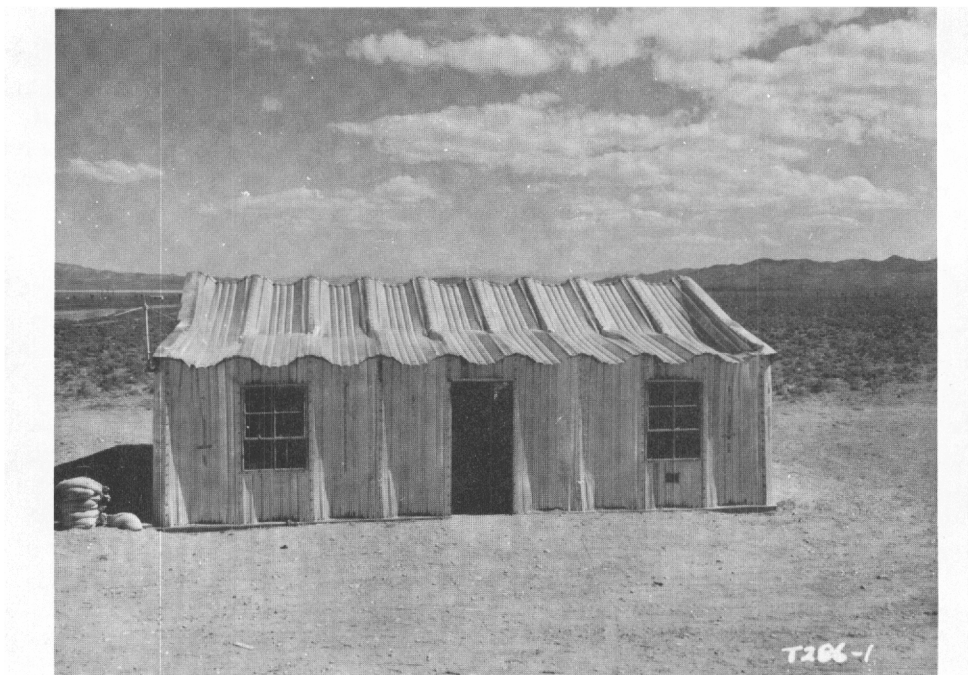
This building, at 6800 ft, was practically destroyed; the roof collapsed and rested at the center on machinery within the building. Front wall segments were wrapped around the machinery, and this provided a block that at least partially prevented additional movement of building wreckage in the downblast direction.

Fig. 2.31 — North side of Behlen Building 31.2-b1 after planned test.

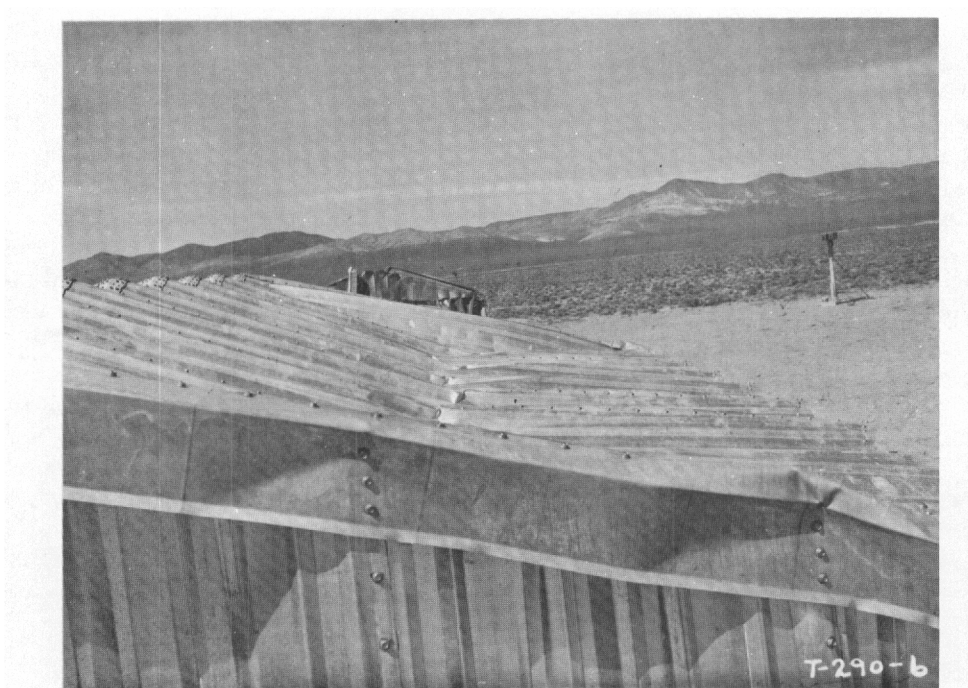
Fig. 2.32 — View looking along north roof of Behlen Building 31.2-b1 after planned test.

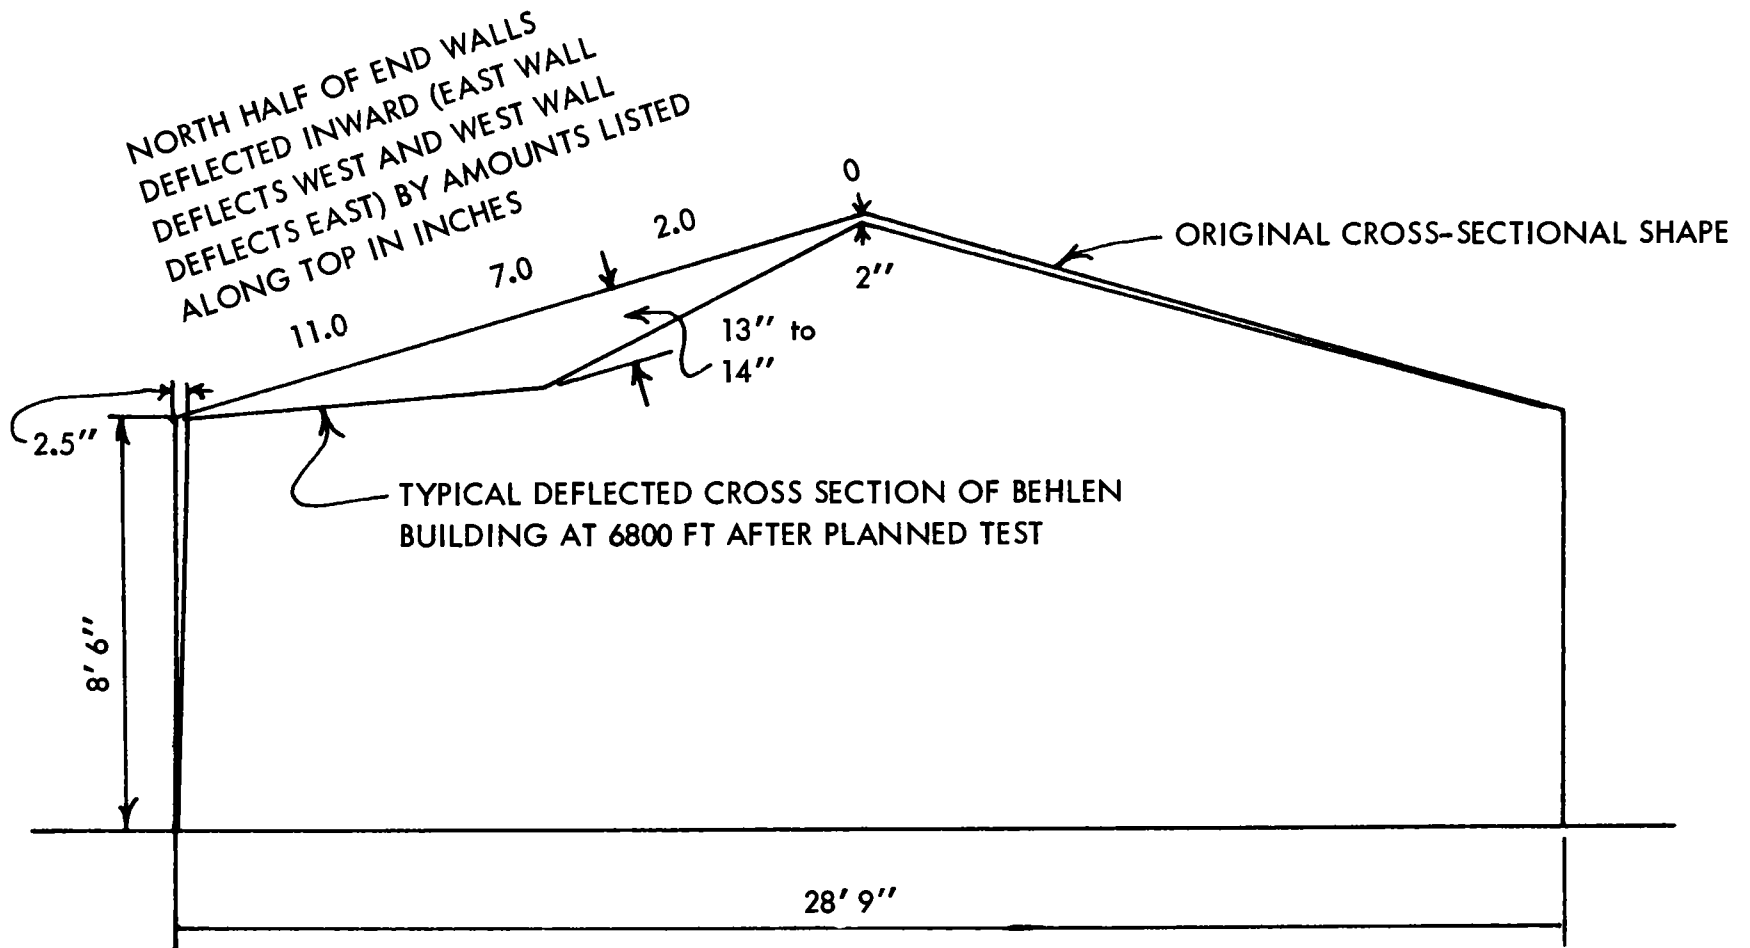
Fig. 2.33—Permanent deflection of Behlen Building 31.2-b1 at 6800 ft after planned test.

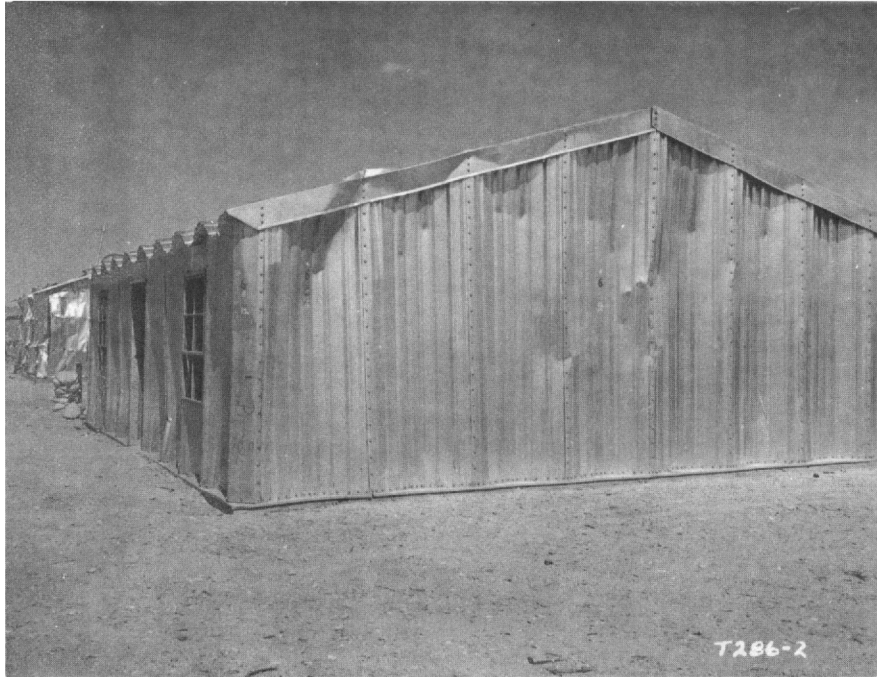
Fig. 2.34—West end of Behlen Building 31.2-b1 after planned test.

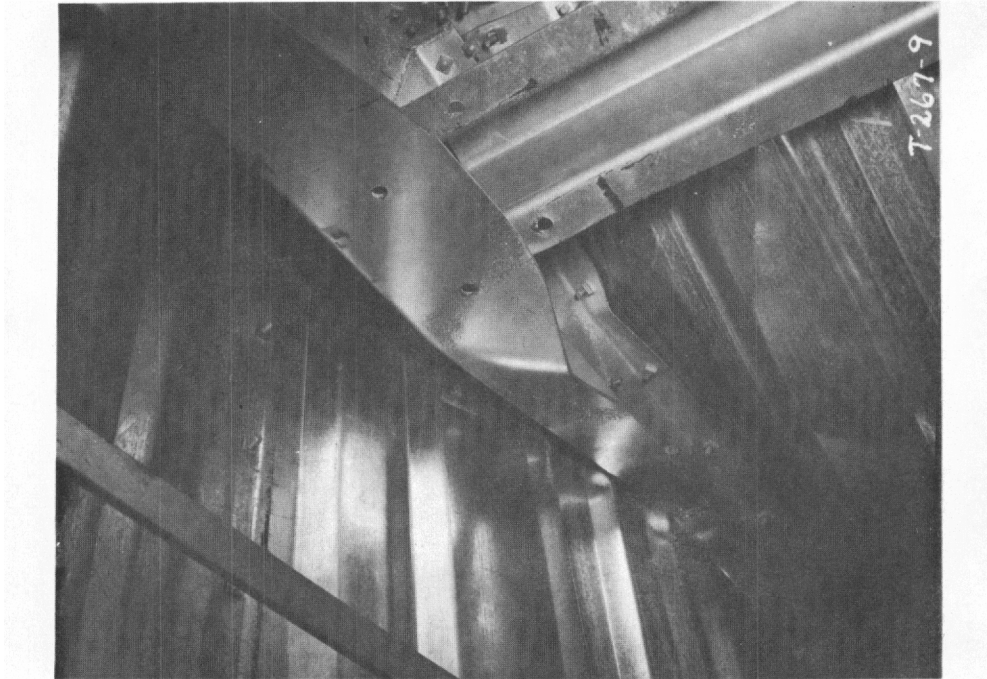
Fig. 2.36—Interior ridge detail at west end of Behlen Building 31.2-b1 after planned test.

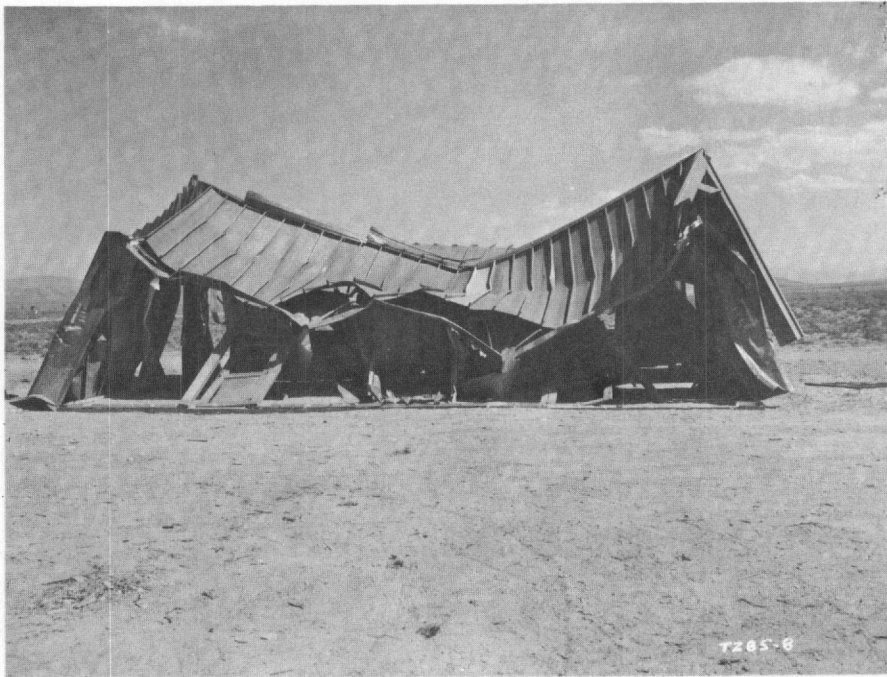
The north side of the building is shown in Fig. 2.37, which also indicates the sag in the roof. Figures 2.38 to 2.41 show various views of the crumpled ends and the south side of the building. Most of the wall segments remained on site, although the wall panels along the north side were largely torn loose from the wall sill connections, as shown in detail in Fig. 2.42, and one piece swept downblast about 50 ft. At the southwest corner of the building, the sill was also torn loose, as shown in Fig. 2.43. The wall paneling remained attached to the sill along 75 per cent of the east end and all the west end.

Fig. 2.37—North side of Armco Building 31.2-d1 after planned test.
